Gusty Winds Cause a Tail Strike in London

The aircraft was on a scheduled flight from London Heathrow Airport to Perth Airport in Australia. Following a normal engine start and taxi, the aircraft was cleared for takeoff

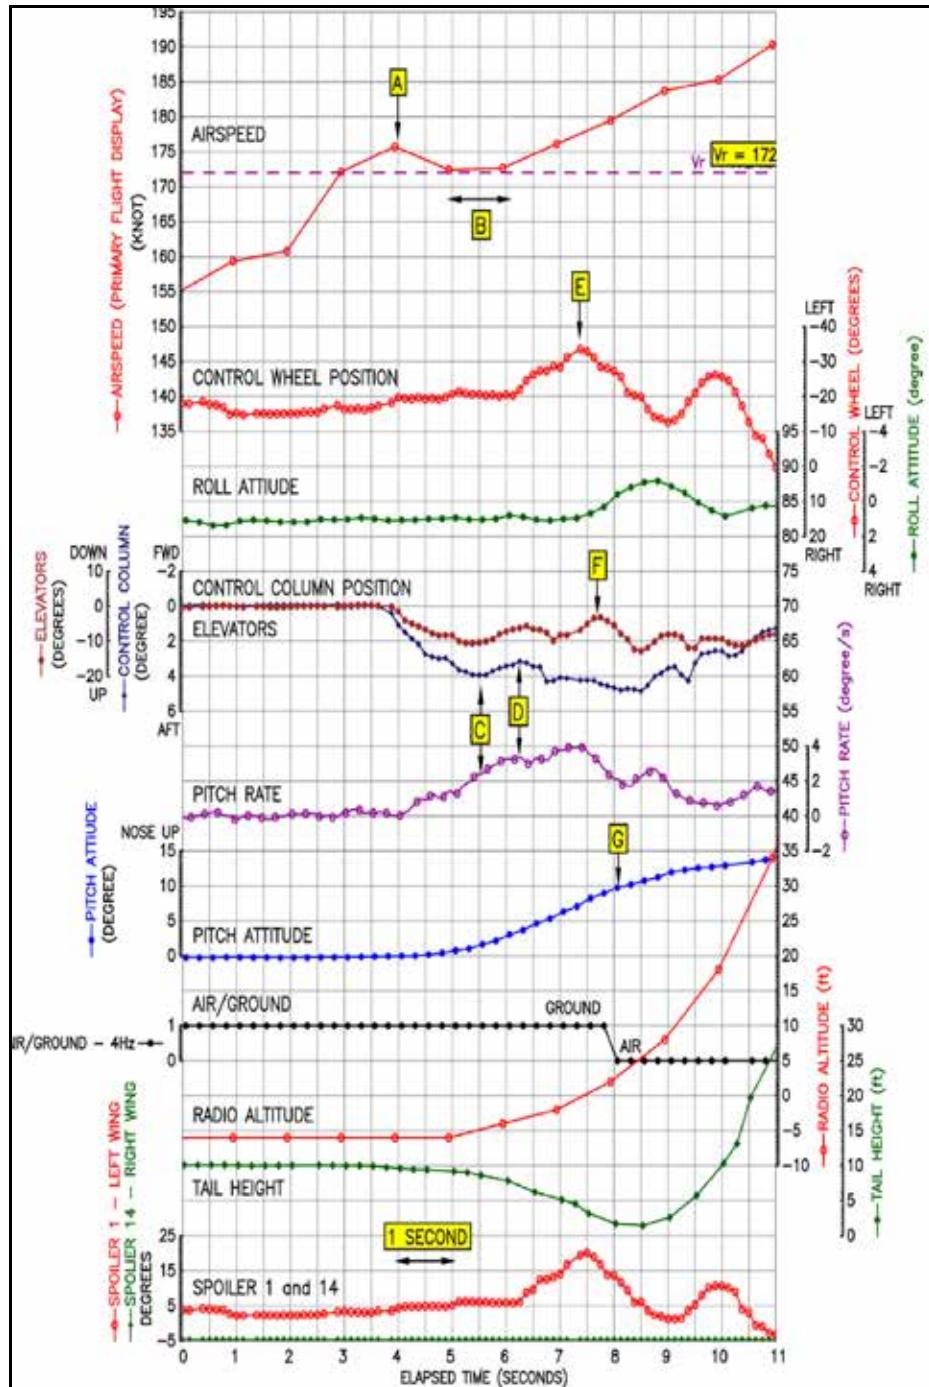
Figure 3
Salient flight data parameters

The aircraft was correctly configured for takeoff, with the flaps set to five, and VR was 172 kt. The data showed that during the takeoff run, there were airspeed fluctuations consistent with the gusty wind conditions. Upon reaching an airspeed of 160 KIAS, the airspeed rapidly increased to 175 KIAS, at which point the PF initiated the rotate (Figure 3 - Point A)

As the aircraft pitched up, the airspeed reduced to 172 KIAS, where it briefly stagnated (Figure 3 - Point B). The PF had progressively moved the control column aft to 4° (Figure 3 - Point C)

at which point the pitch rate was just over $2^{\circ}/s$; the maximum aft movement of the control column was 9.8° . The control column was then moved slightly forward (Figure 4 - Point D) to 3° , but the pitch rate increased to $3.2^{\circ}/s$. The airspeed then started to increase, which coincided with the PF pulling back on

the control column whilst also moving the control wheel from 20° counter-clockwise (CC) to 33° CC (Figure 3 - Point E). This caused the left spoilers to further deploy from 5° to 20°

$4^{\circ}/s$, and the calculated tail height above the runway was 4.5 ft. The aircraft's tail strike prevention system then started to move the elevators (Figure 3 - Point F), which reduced the pitch rate to just over $2^{\circ}/s$. The pitch attitude at takeoff was about 9.7° (Figure 3 - Point G) and the tail height indicated just less than 2 ft.

The aircraft manufacturer analysed the FDR and CPL data and stated: 'The near tail contact was the result of a combination of factors including: high pitch rate close to lift-off, airspeed stagnation, and control wheel usage deploying spoilers on the left wing. The high pitch rate allowed pitch attitude to increase towards the tail contact attitude prior to airspeed reaching lift-off speed. The deployed spoilers on the left wing decreased lift and necessitated a higher pitch attitude for lift-off.'
