## FEDERATION OF INDIAN PILOTS

FIP/MOCA/26-03

**TECHNICAL NOTE IN COMPLIANCE OF ANNEX 13 I.R.O AIR INDIA  
171 ACCIDENT OF 12TH JUNE 2025, PROPOSING OEM/ INCIDENT  
INVESTIGATION REPORT EVIDENCE LED ELECTRICAL REVERSE  
VOLTAGE PATHWAY DUE TO BATTERY SHORT CIRCUIT AS A  
CREDIBLE CAUSE FOR DUAL ENGINE FUEL SWITCHES TRANSITION  
TO CUTOFF.**

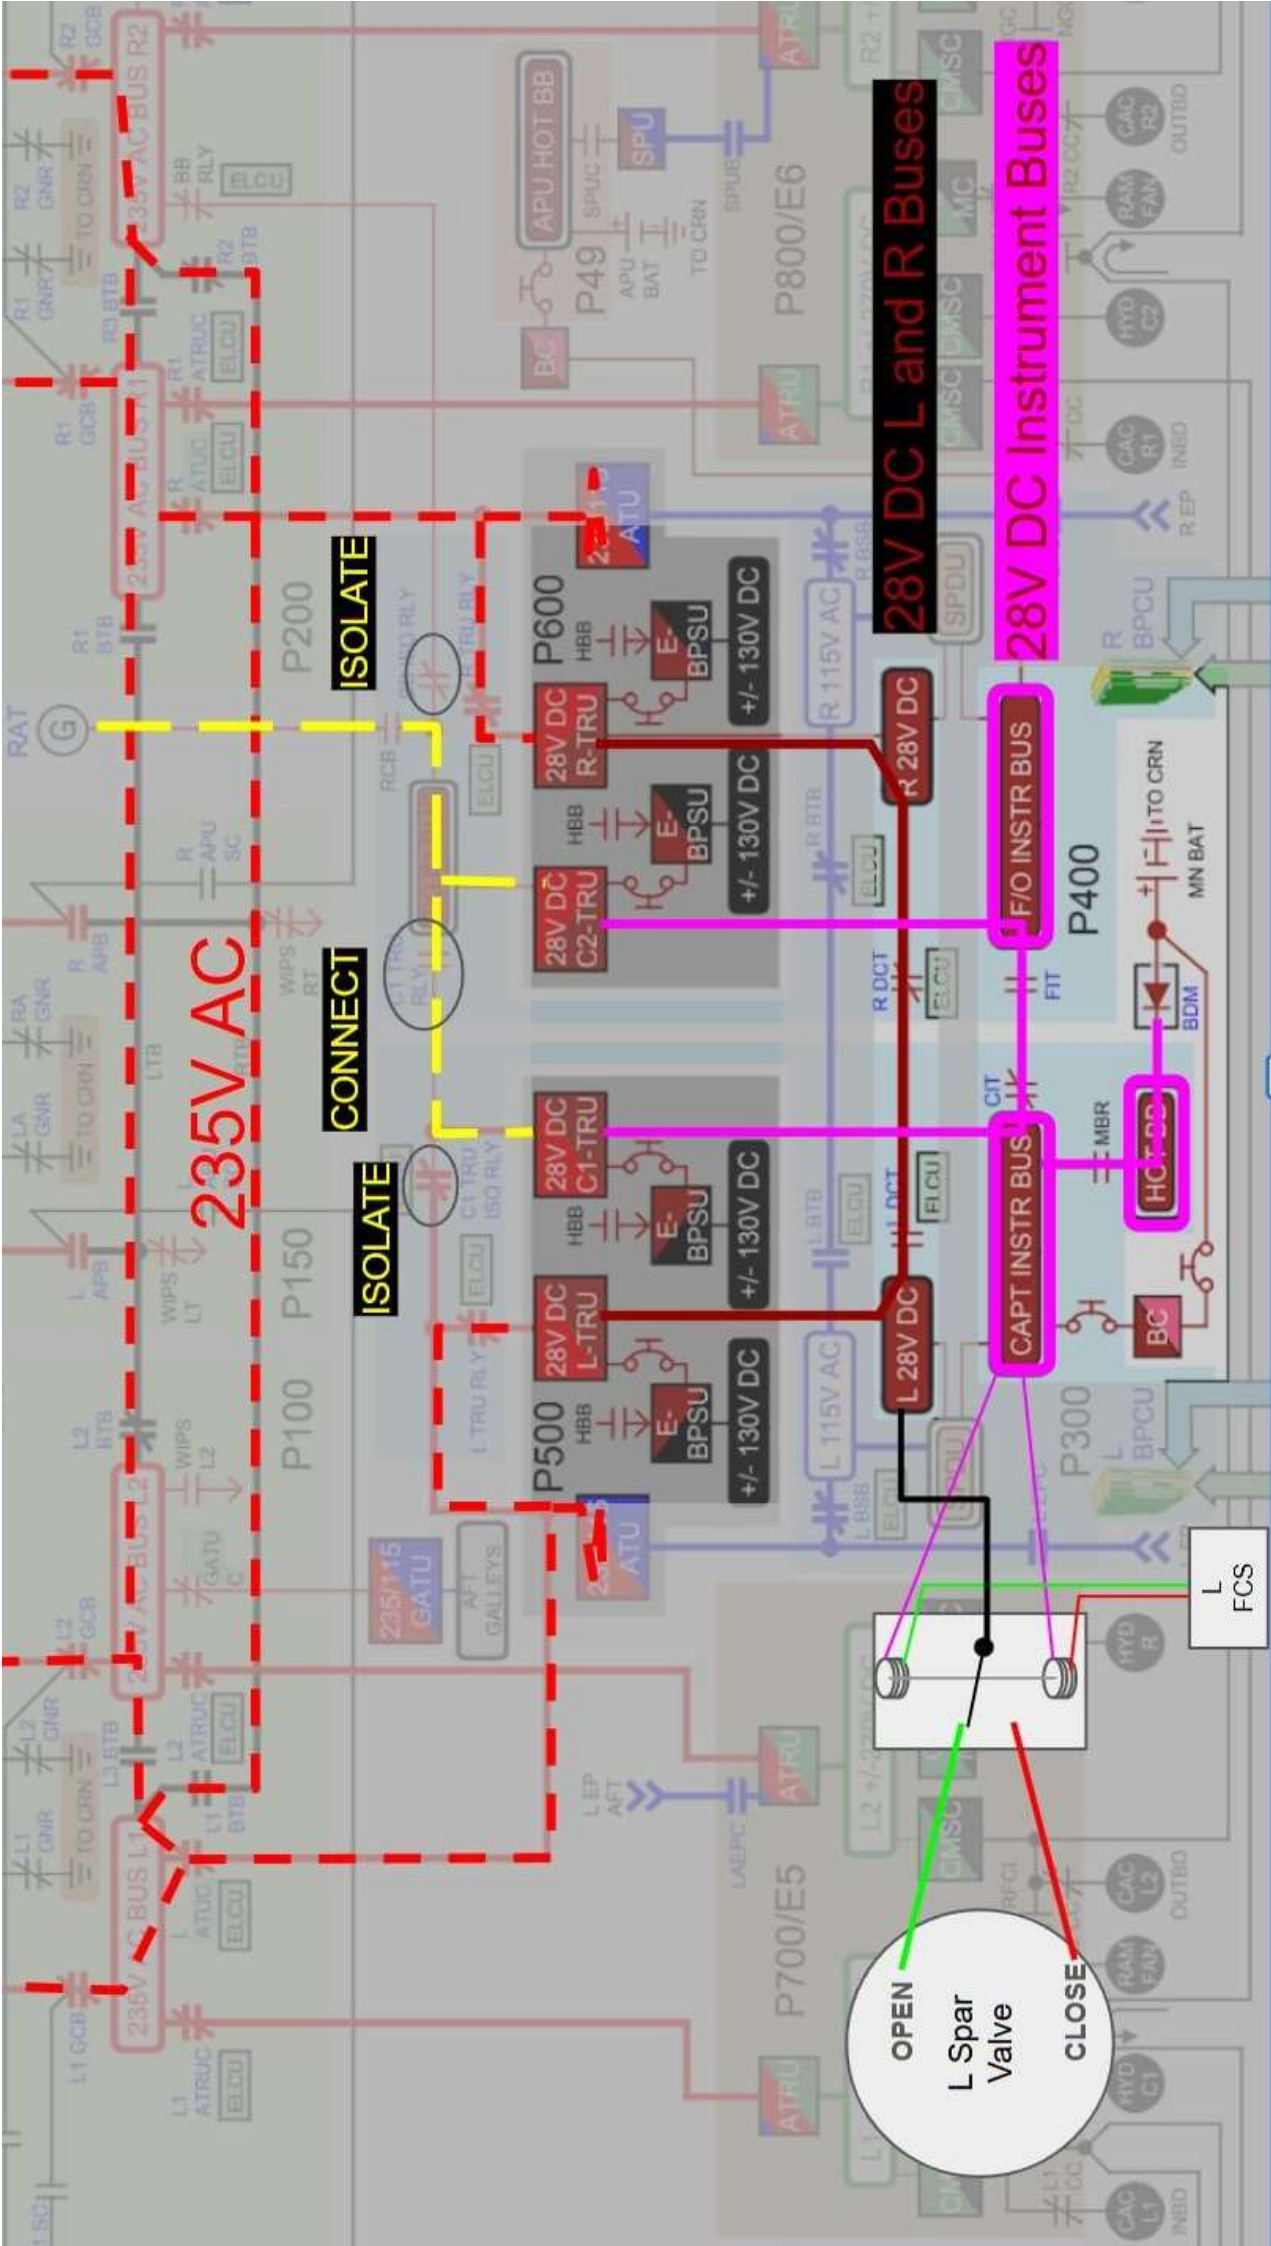
## IMAGE 2

- d) With a common return path after RAT deployment, **reversal of voltage across the dual-coil relay energises the cut-off path driving the spar valve closed**, as shown in the Fuel Relay (P300) to Spar Valve section of the diagram, **which can affect both engines, causing near-simultaneous switching from RUN to CUTOFF without pilot input** (Refer Annexure 4, Image 2).
