Atlas Air Flight 3591

On February 23, 2019, at 1239 central standard time, Atlas Air Inc. (Atlas) flight 3591, a Boeing 767-375BCF, N1217A, was destroyed after it rapidly descended from an altitude of about 6,000 ft mean sea level (msl) and crashed into a shallow, muddy marsh area of Trinity Bay, Texas, about 41 miles east-southeast of George Bush Intercontinental/Houston Airport (IAH), Houston, Texas.

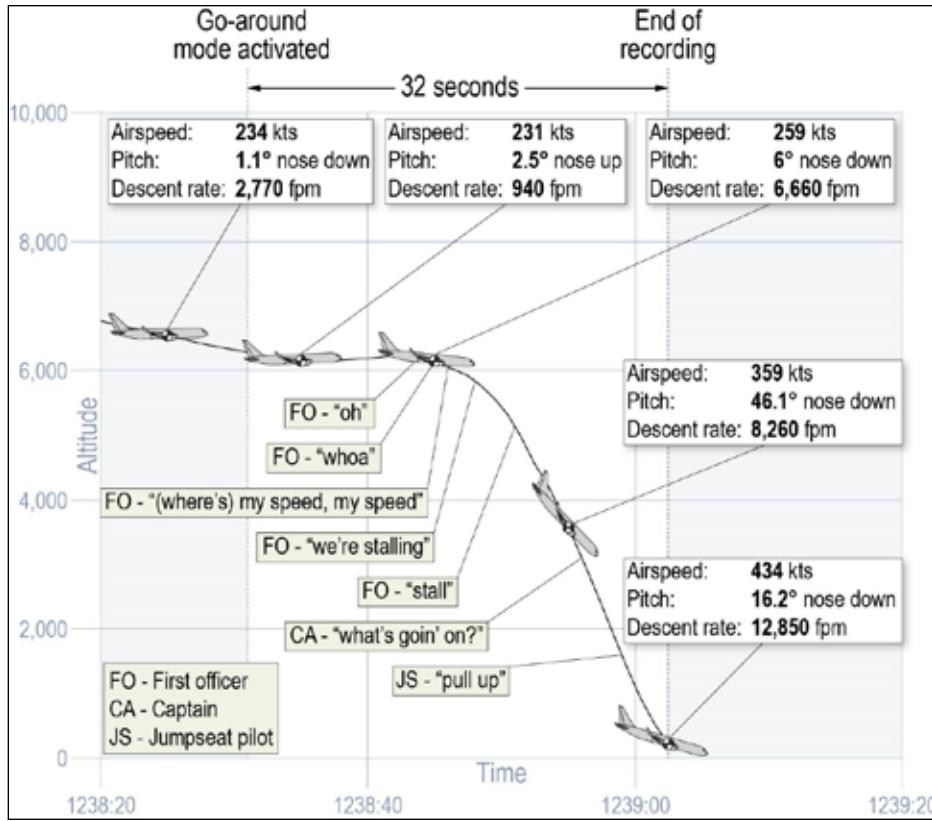
miles from IAH at an altitude of 6,300 ft msl. During the next 6 seconds, the airplane's automated flight functions commanded nose-up pitch and an increase in engine thrust, consistent with go-around mode-driven commands. Neither crewmember made any callout to indicate intentional activation of the go-around mode or took action to disconnect the automation. The captain continued to receive and respond to routine air traffic control (ATC) communications. About 1238:36, the speedbrakes were retracted, then the airplane's elevators moved in response to manual control inputs to command nose-down pitch. The amount of nose-down pitch continued to increase, and the airplane entered a steep descent. Beginning at 1238:44, the FO said, "oh," then said in an elevated voice "whoa... (where's) my speed, my speed...we're stalling," he then exclaimed "stall" at 1238:51. A review of FDR data determined that the airplane's airspeed and pitch parameters were not consistent with the airplane at (or near) a stalled condition, and none of the stall warning system indications activated. At 1238:56, the captain asked, "what's goin' on?" Three seconds later, the pilot riding in the jumpseat shouted, "pull up." About this time, the elevators moved consistent with manual control inputs to command airplane nose-up pitch. The nose-up pitch control inputs were held for the remaining 7 seconds of the flight but were unsuccessful in arresting the airplane's descent in time to prevent its crash into the marsh (see figure 1).

FDR data at 1238:31 showed that the airplane's automated flight system status for the go-around mode changed to "activated," and the CVR recorded a "click" at this time. In the accident, the airplane's configuration with autopilot and autothrottle engaged, the autopilot/flight director system (AFDS) and autothrottle would be expected to respond by controlling airplane pitch, roll, and thrust to maintain ground track, hold the existing airspeed, and establish a climb rate of at least 2,000 ft per minute. During the next 6 seconds, automated flight commands advanced the thrust levers to about 80° to 82°, resulting in increased thrust and longitudinal acceleration, and moved the control column and elevators to command nose-up pitch; during this time, the airplane's pitch increased to about 4° nose up.

About 1238:36, the speedbrake lever was moved from the extended position to the armed position, which retracted the speedbrakes. Recorded airplane parameters at this time, including those for air/ground sensing and flap setting criteria, did not meet the conditions for automatic speedbrake retraction. Between about 1238:38 to 1238:56, the airplane pitched nose down and continued to accelerate, reaching a peak longitudinal acceleration of 0.27 g at 1238:42.

airplane's nose-down pitch during this time progressed rapidly to about 49° nose down, and the airplane entered a steep descent. At 1238:40, the CVR recorded a beeping sound consistent with the "owl" beeper; the FO then said, "oh" at 1238:44 and "whoa" at 1238:45.27. Between 1238:46 and 1238:56, the right elevator was in a more airplane nose-down position than the left elevator, which would be consistent with the captain and the FO each applying differing manual inputs on their respective control columns.
