Atlas Air Flight 3591

On February 23, 2019, at 1239 central standard time, Atlas Air Inc. (Atlas) flight 3591, a Boeing 767-375BCF, N1217A, was destroyed after it rapidly descended from an altitude of about 6,000 ft mean sea level (msl) and crashed into a shallow, muddy marsh area of Trinity Bay, Texas, about 41 miles east-southeast of George Bush Intercontinental/Houston Airport (IAH), Houston, Texas.

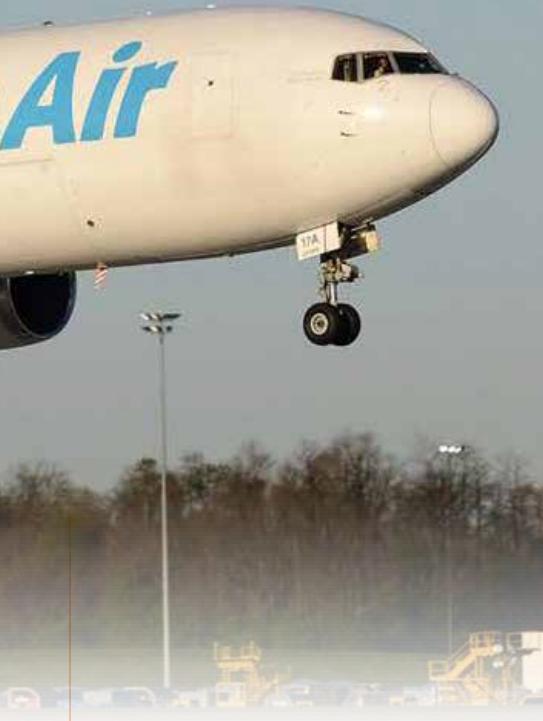
miles from IAH at an altitude of 6,300 ft msl. During the next 6 seconds, the airplane's automated flight functions commanded nose-up pitch and an increase in engine thrust, consistent with go-around mode-driven commands. Neither crewmember made any callout to indicate intentional activation of the go-around mode or took action to disconnect the automation. The captain continued to receive and respond to routine air traffic control (ATC) communications. About 1238:36, the speedbrakes were retracted, then the airplane's elevators moved in response to manual control inputs to command nose-down pitch. The amount of nose-down pitch continued to increase, and the airplane entered a steep descent. Beginning at 1238:44, the FO said, "oh," then said in an elevated voice "whoa... (where's) my speed, my speed...we're stalling," he then exclaimed "stall" at 1238:51. A review of FDR data determined that the airplane's airspeed and pitch parameters were not consistent with the airplane at (or near) a stalled condition, and none of the stall warning system indications activated. At 1238:56, the captain asked, "what's goin' on?" Three seconds later, the pilot riding in the jumpseat shouted, "pull up." About this time, the elevators moved consistent with manual control inputs to command airplane nose-up pitch. The nose-up pitch control inputs were held for the remaining 7 seconds of the flight but were unsuccessful in arresting the airplane's descent in time to prevent its crash into the marsh (see figure 1).

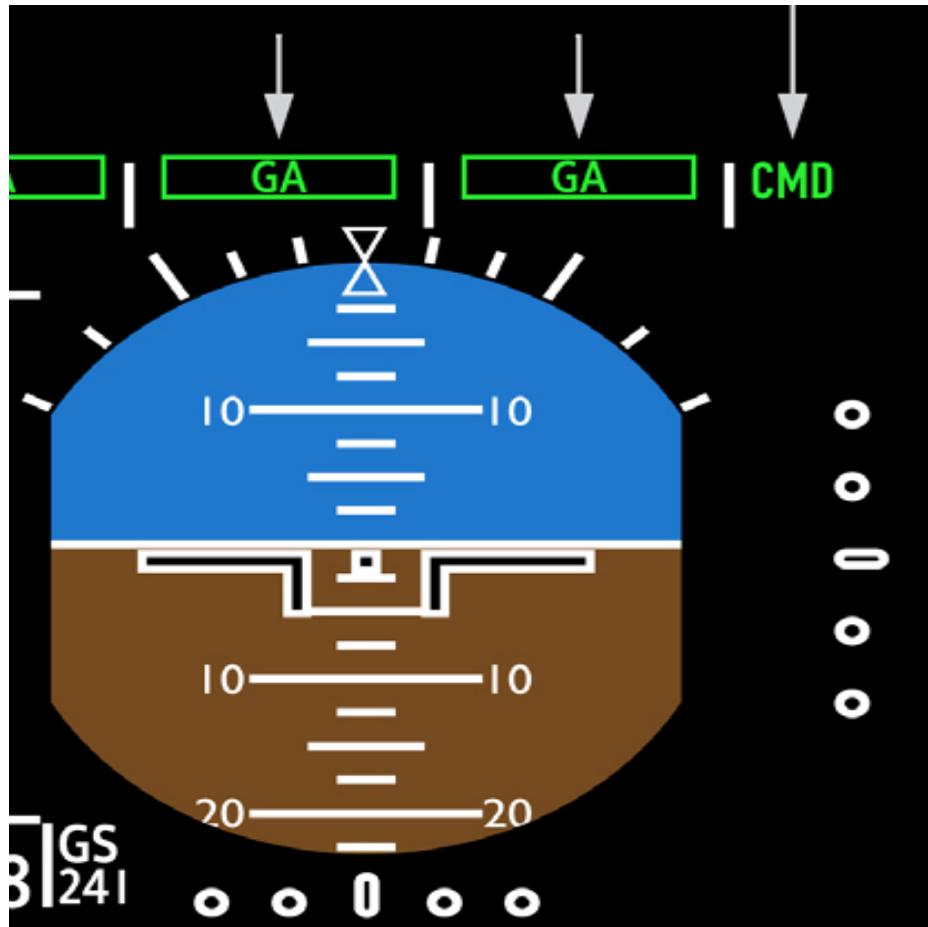
Investigators performing the simulator scenarios had the pilot hold the speedbrake lever using a variety of different hand grip and arm positions. The investigators observed that, when the right-seat PF kept his left hand on the speedbrake lever during the descent (consistent with Atlas’ procedures), the PF’s left hand and wrist could be under the thrust levers

and close to the left go-around switch. (The distance between the hand/wrist and the go-around switch varied with different hand grip and arm positions.) The scenarios showed that, if a PF were wearing a watch on the left wrist (as photographs showed the accident FO had done at times), this could result in decreased clearance beneath the go-around switch (see figure 12). Investigators also observed that cycling the EFI switch (to reset the respective SG) took less than 4 seconds to accomplish, did not change the ADI’s presentation of the airspeed data, and did not affect the information displayed by the two conventional Mach/airspeed indicators.
