# Air Niugini Flight 73

On 28 September 2018, at 23:24:19 UTC a Boeing 737-8BK aircraft, registered P2-PXE (PXE), operated by Air Niugini Limited, was on a scheduled passenger flight number PX073, from Pohnpei to Chuuk, in the Federated States of Micronesia (FSM) when, during its final approach, the aircraft impacted the water of the Chuuk Lagoon, about 1,500 ft (460 m) short of the runway 04 threshold.

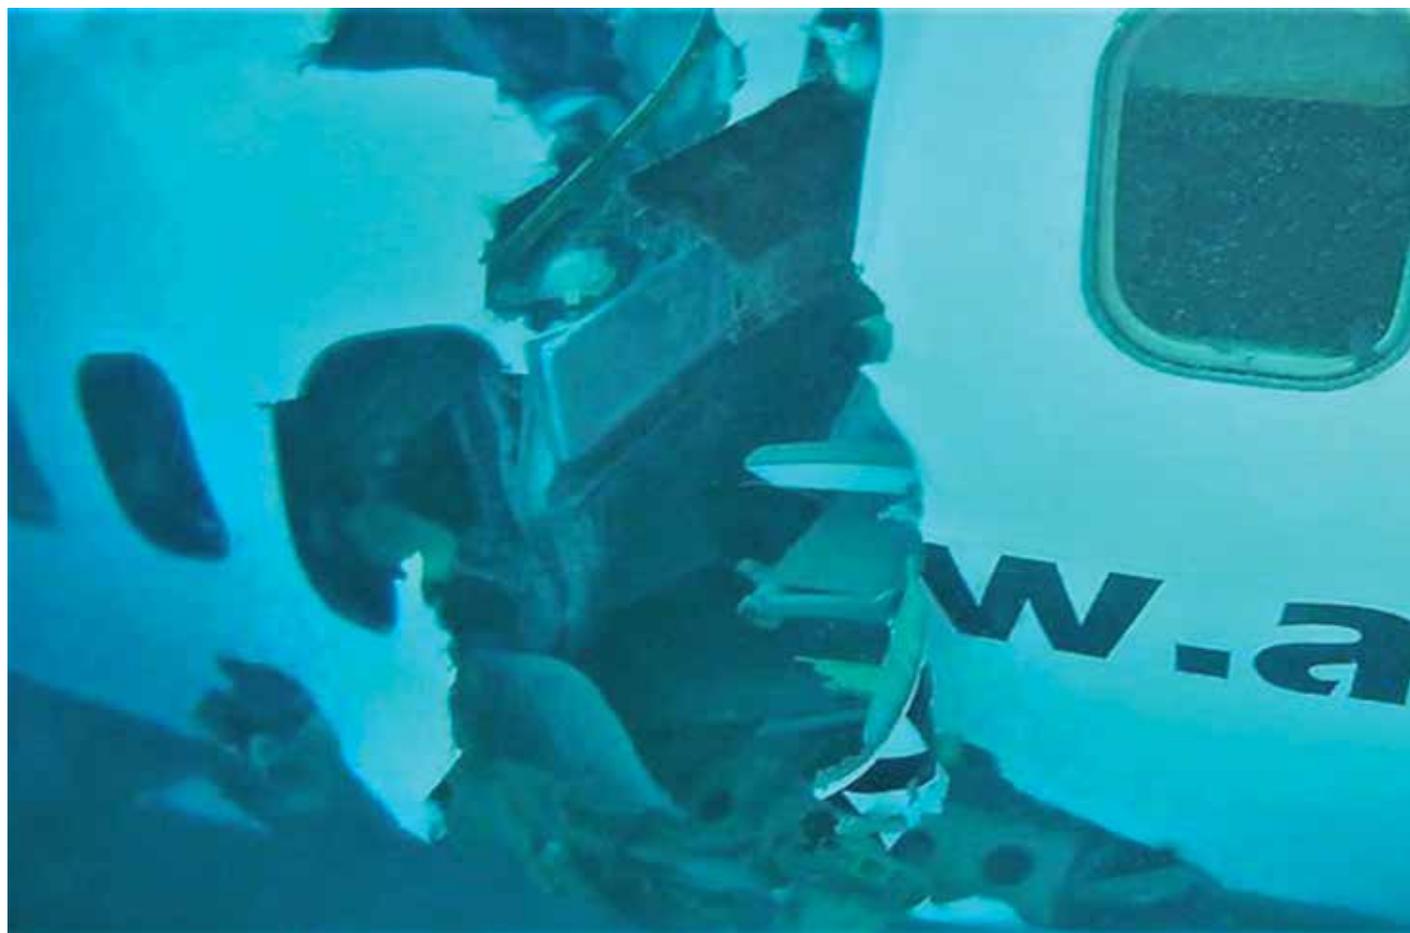
The aircraft deflected across the water several times before it settled in the water and turned clockwise through 210 deg and drifted 460 ft (140 m) south east of the runway 04 extended

centreline, with the nose of the aircraft pointing about 265 deg.
